**INVESTIGATION OF CHILDREN'S POOL  
LA JOLLA, CALIFORNIA**

**APRIL 29, 1998  
TESD PROJECT NO. 64541**

**PROJECT:** Investigation of Children's Pool  
La Jolla, California

**SUBJECT:** Phase I, Feasibility of Reopening Sluiceways

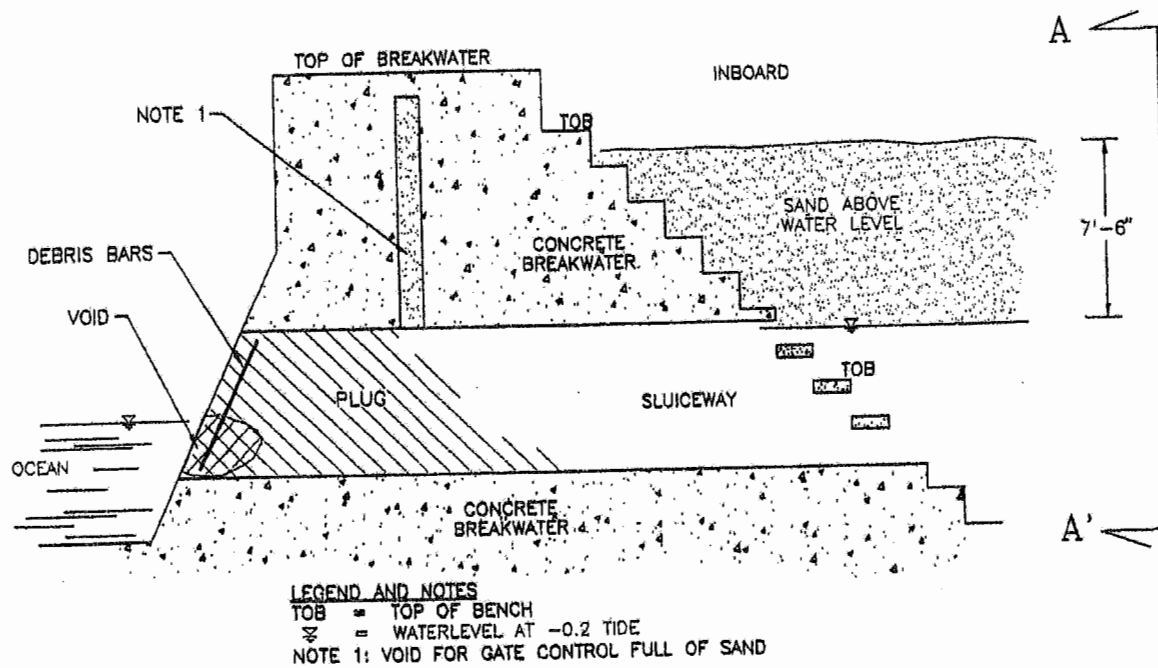
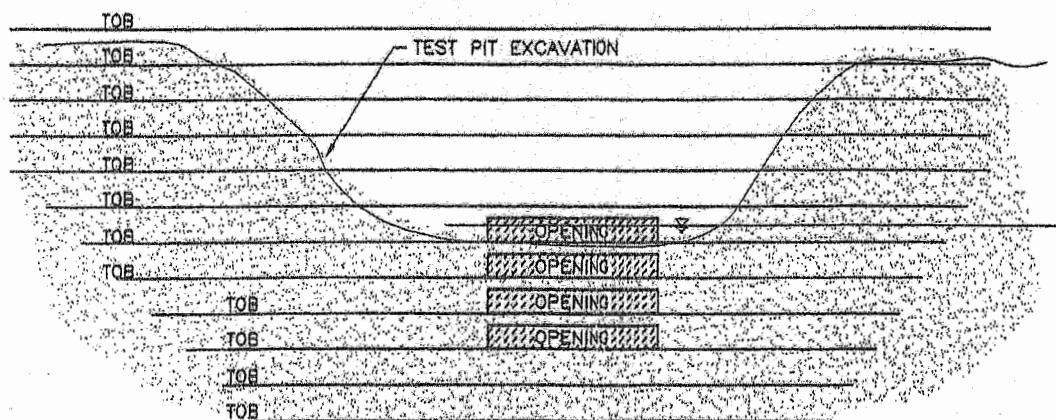
## CROSS-SECTION OF BREAKWATER

Plate # 1 also shows a section through the breakwater and illustrates the conditions as they existed at 2:00 pm on April 7, 1998. The tide was -0.2 feet. The ground water inside the breakwater was approximately four feet above the water level on the ocean side of the breakwater.

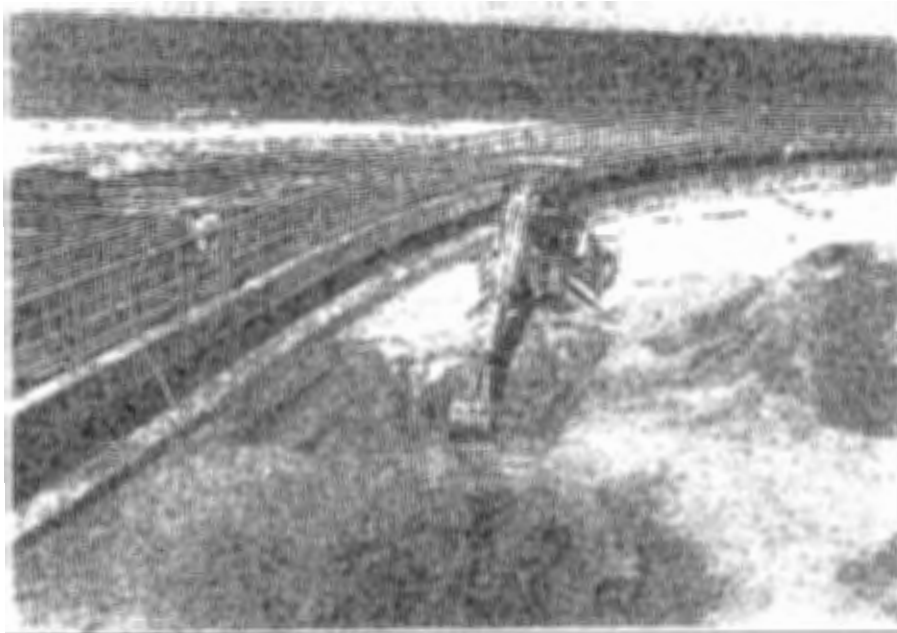
**Beach Side:** A backhoe was used to excavate the sand on the beach side in order to expose the opening of the outboard sluiceway. (Photographs #1 and #2) The water table was found six inches below the top of the sluiceway opening. During our field work it appeared that the water table did not vary appreciably with the tide. The openings of the sluiceways appear to be protected. The top six inches of each step was continued across the opening. Refer to photographs 2 through 5 and Plate # 1. This condition was found for the top two steps on the outboard sluiceway and we assume the same condition exists for the remainder of the openings. The surface of the ground water contained clean pieces of styrofoam, candy wrappers, etc. This is an indication that there is currently some water movement through the sluiceways. This side of the sluiceway is plugged with rounded cobbles, seaweed and debris. Photograph #5.

1. Backhoe adjacent to outboard sluiceway.

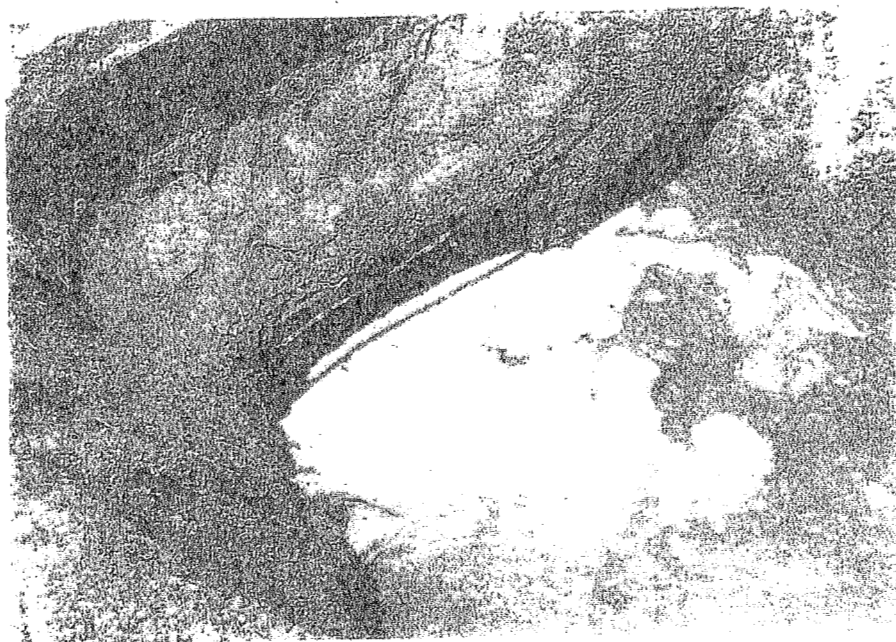
3. Water table six-inch (6") below top of outboard sluiceway.

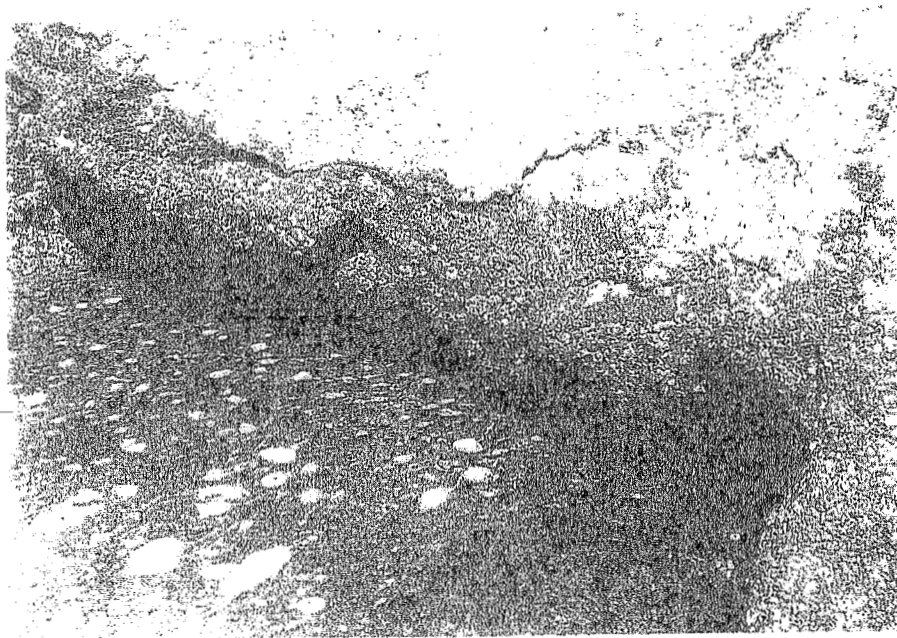
Three of the four sluiceways had openings in the bottom of the plugs. Sluiceway #2 had an opening three feet high and extended three feet into the breakwater. Sluiceway #3 is about one foot high. Sluiceway #4 is about one-half foot high. These openings were probably caused by wave action erosions.

8. Opening at bottom of sluiceway.

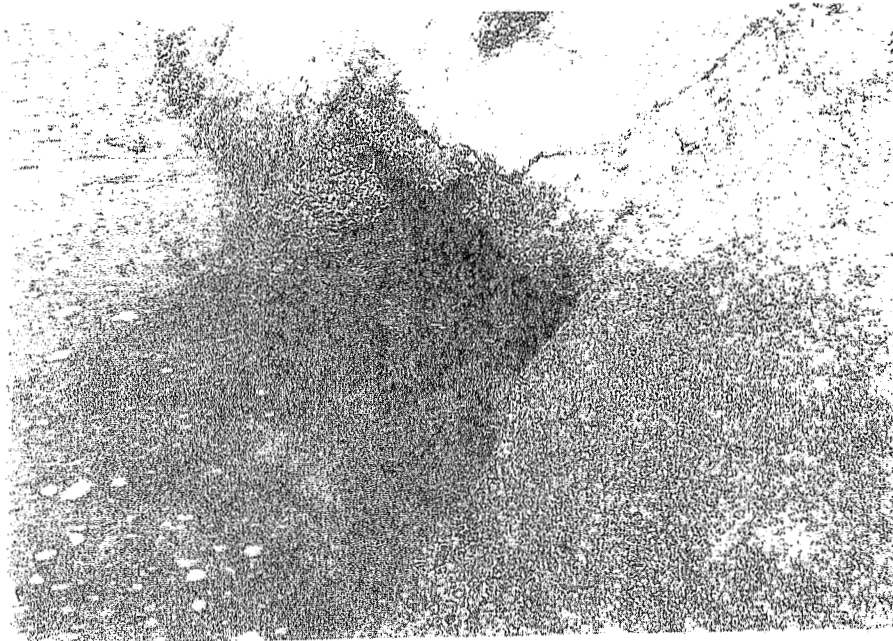
These sluiceways are protected by four large (approximately 1 1/2 inch in diameter) vertical steel bars spaced about nine inches on center.

9. Opening at bottom of sluiceway. Note: debris bars

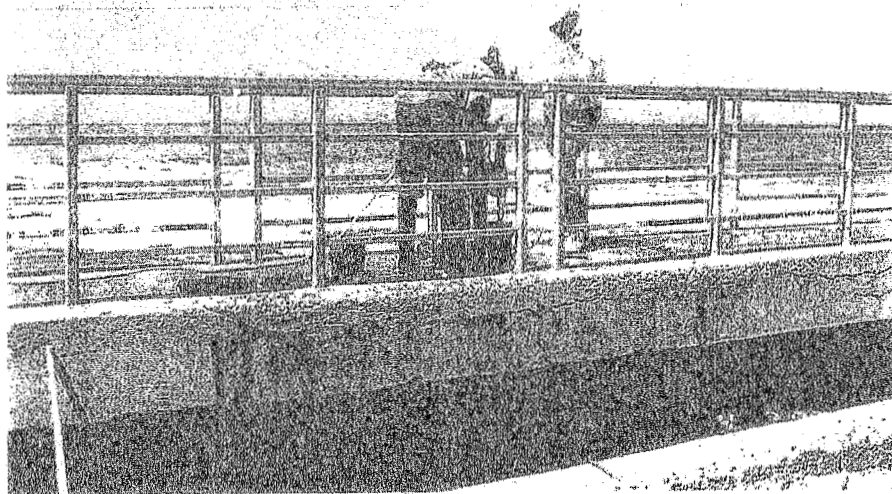
Core #1 (photograph # 13) was cut in the center of the walkway directly above the outboard sluiceway. Due to horizontal cracks in the concrete, the 12-inch core was in three sections. Sand was encountered directly below the core. A hand auger was used to determine that the sand extended a minimum of three feet below the walkway.

11. Coring above outboard sluiceway. Core #1.

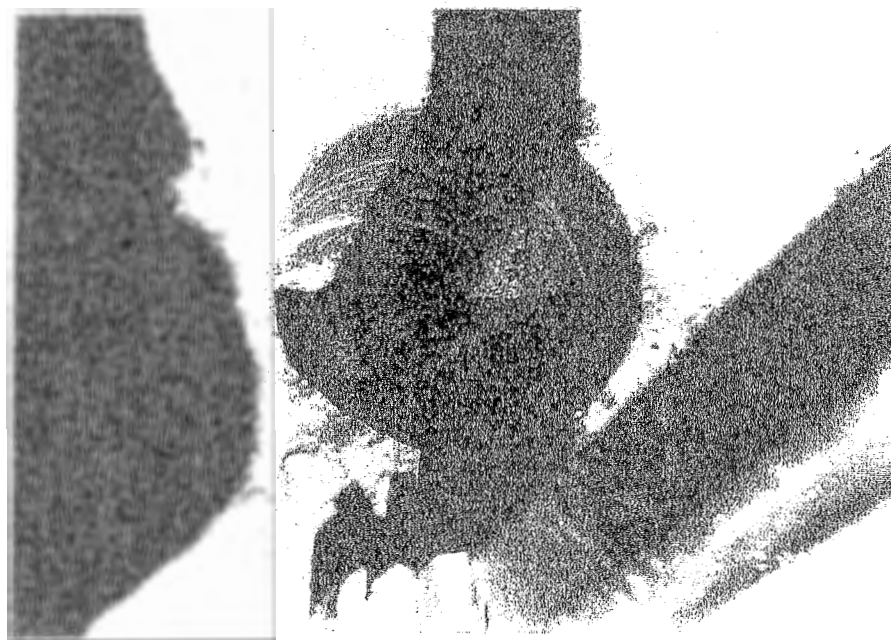
12. Core hole #1 - Note: sand in bottom.

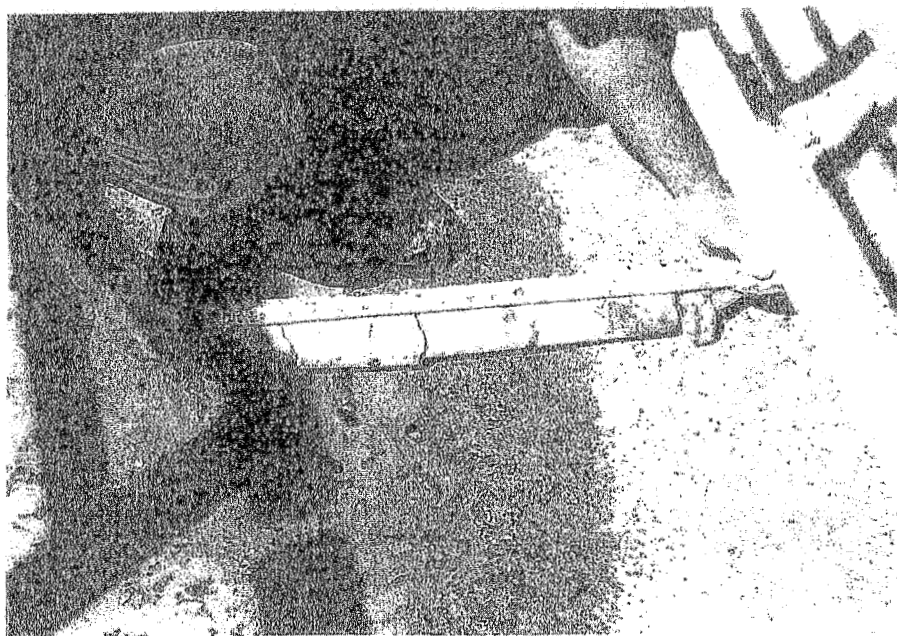
14. Core #2

Core #2 (photograph # 13) was cut 12 feet outboard from core #1. The concrete extended to a depth of 20-inches. Sand was encountered below the concrete.

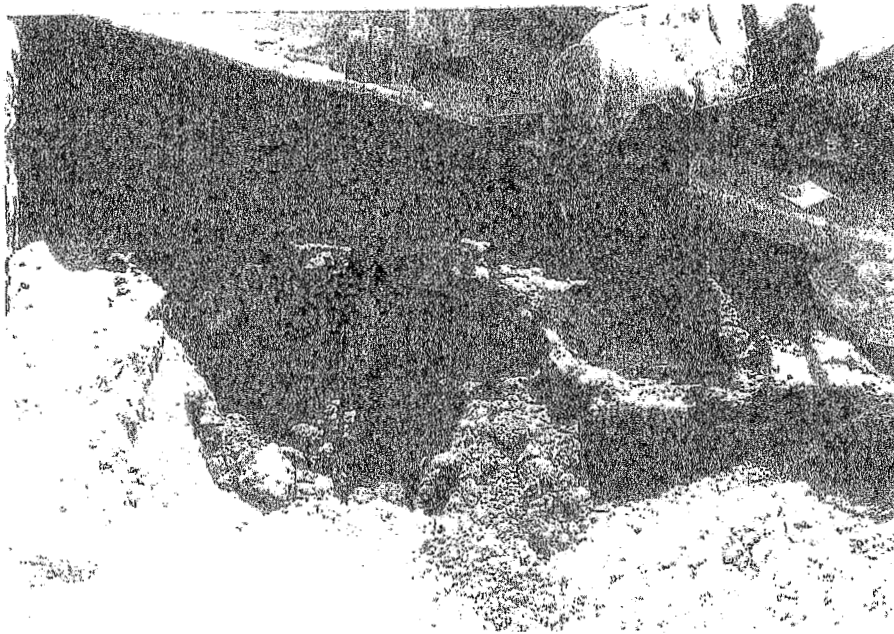
Red silty sand containing clay soil was observed on the inside of the cove at the interface of the sea wall and the sandstone cliff. This material extends approximately 24 feet along the wall and 12 feet along the sand stone. The thickness varies from two to three feet. This soil was probably placed in this location to prevent leakage at the interface of the sandstone and the concrete sea wall. (Photograph # 15) The following presents the results of our laboratory testing performed on a sample of this soil.

15. Red Clay

If the beach sand is removed, care should be used to not disturb the red silty sand located at the interface between the breakwater concrete and sandstone. Removing this soil may allow erosion and undermining of the abutment connections. This red soil should remain covered or protected by some other erosion control method.
