CALIFORNIA COASTAL COMMISSION

6-14-0691-A1 AND 6-15-0223-A2

(CHILDREN'S POOL)

EXHIBITS

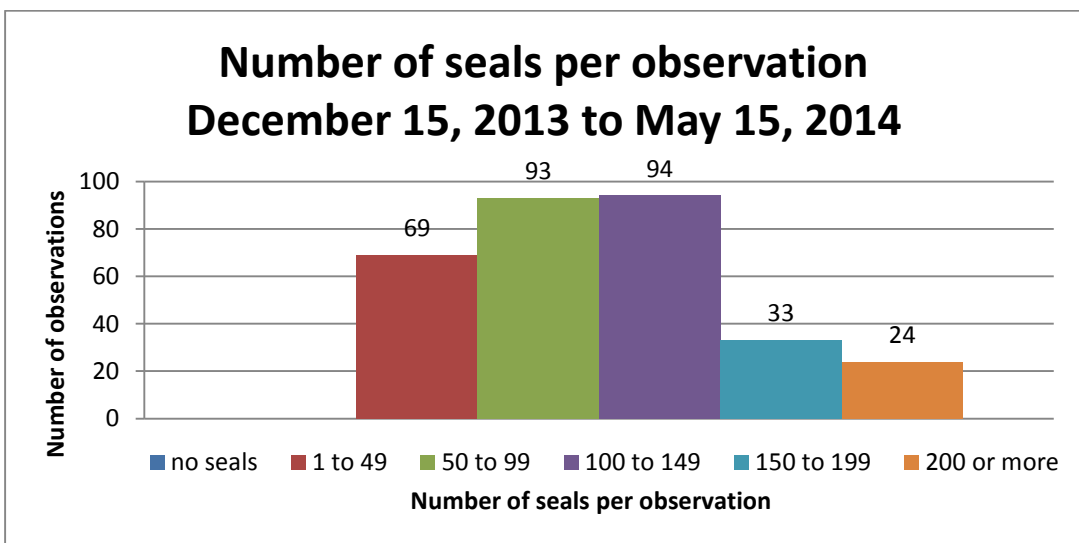
The preceding graphs displayed the average number of seals per observation per month. The following graphs show the number of seals counted per observation divided into groups. This graph can be read as follows: example, in 29 of the 412 observations made from December 15, 2015 to May 15, 2016 between 1 and 49 seals were counted.

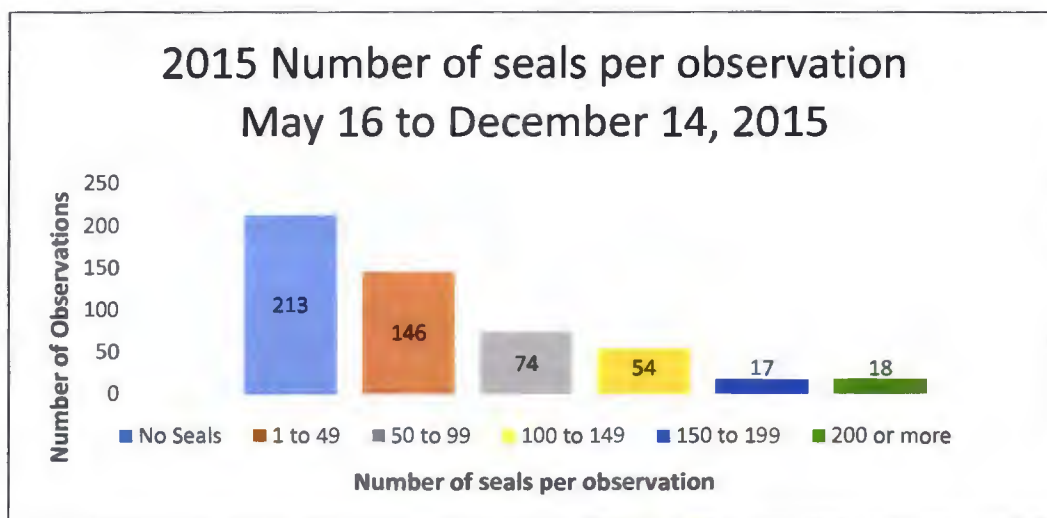
Figure 13

Graphs of the number of seals per observation during the non-closure period (figures 13 through 16) the previous four years are included for comparing closure period versus shared use/guideline rope period haul-out patterns:

Graphs of the number of seals per observation during the non-closure period (figures 13 through 16) the previous four years are included for comparing closure period versus shared use/guideline rope period haul-out patterns:

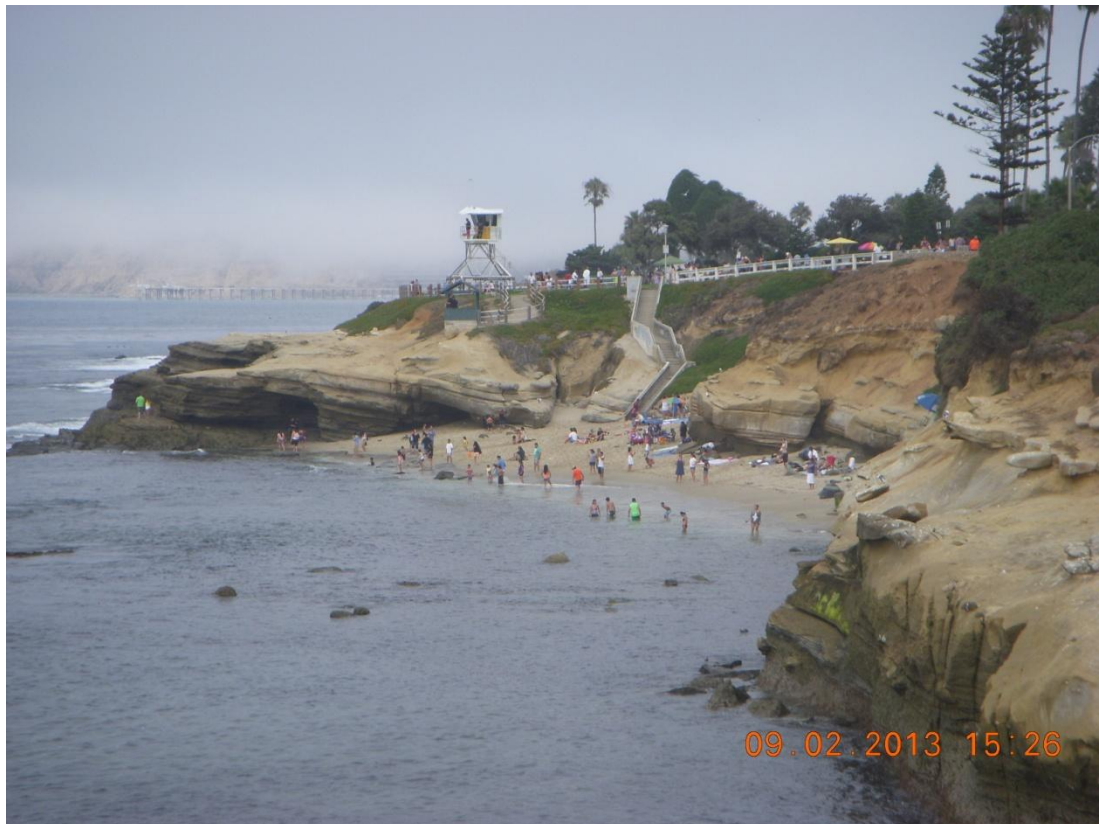
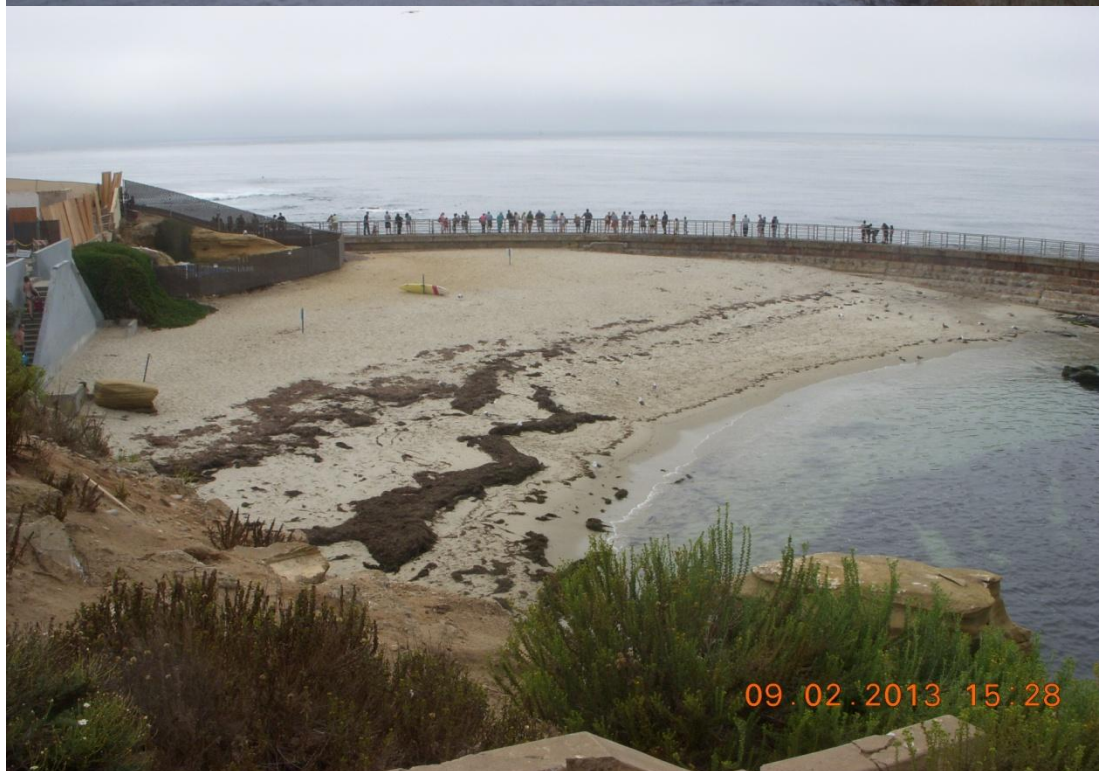
Rope effectiveness: Top photo is Shell Beach taken from Children's Pool Gazebo. Bottom photo is Children's Pool beach also taken from the gazebo 2 minutes later.

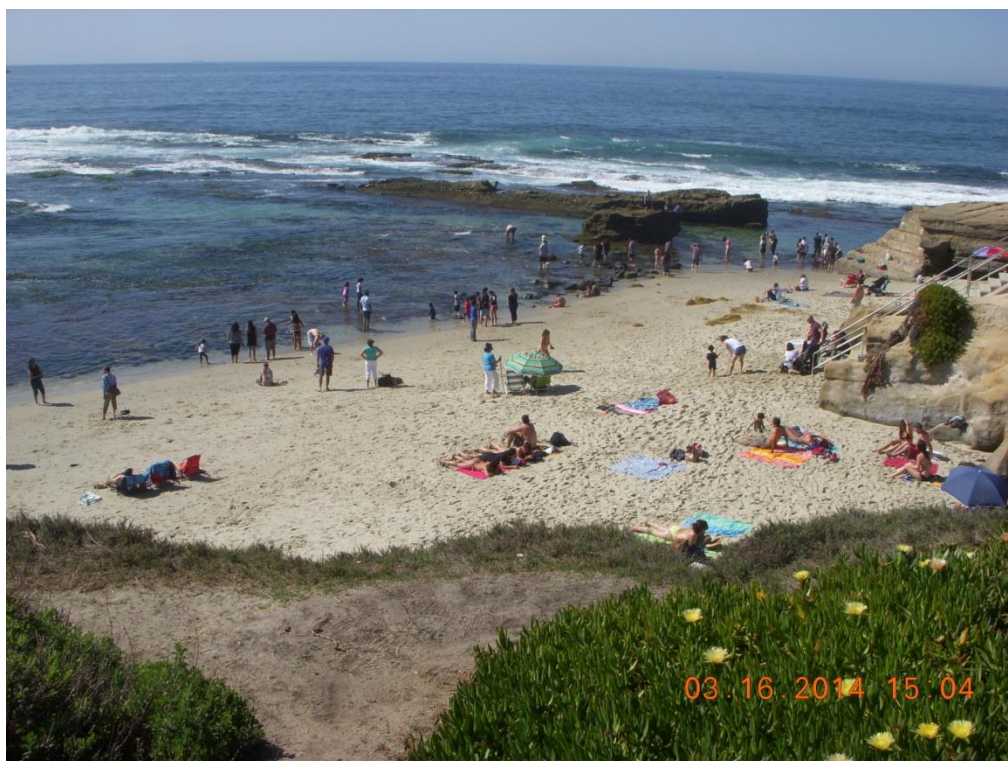
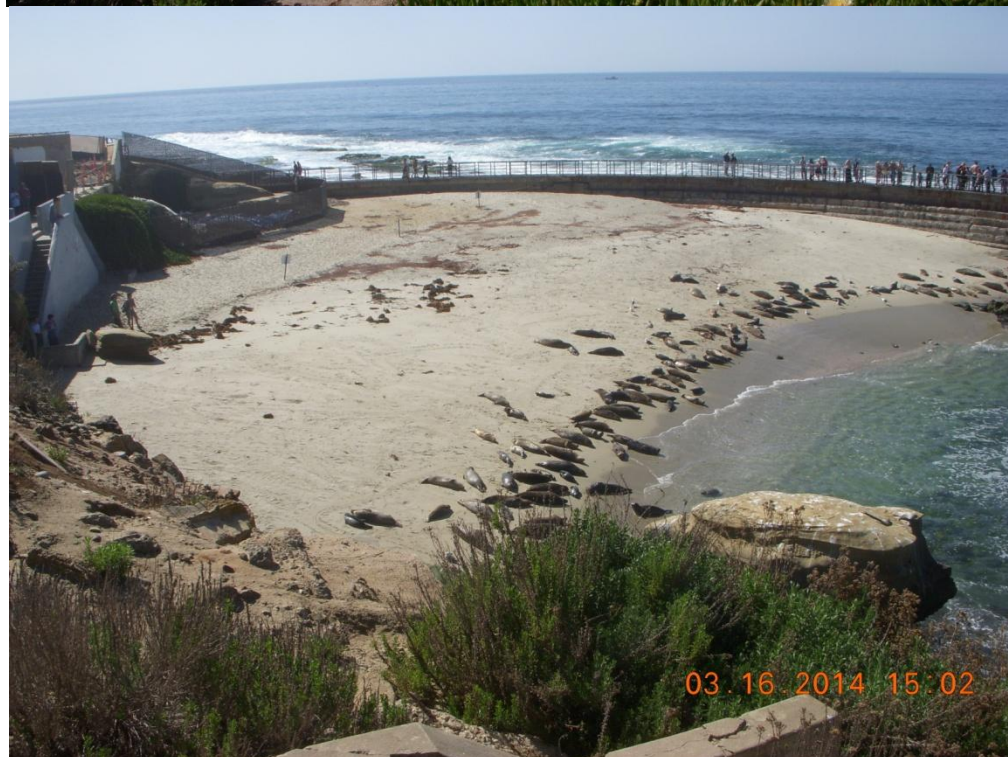
Rope effectiveness: Top photo is South Casa beach just south of the Children's Pool taken 2 minutes after the bottom photo.

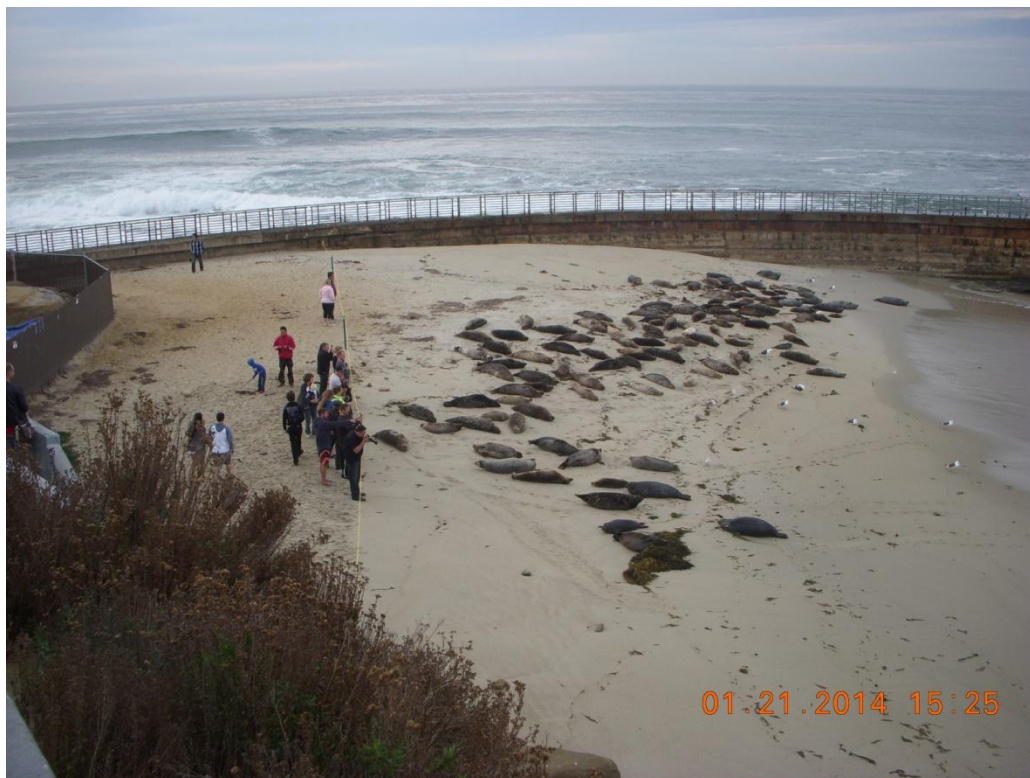
Rope effectiveness 1/21/2014

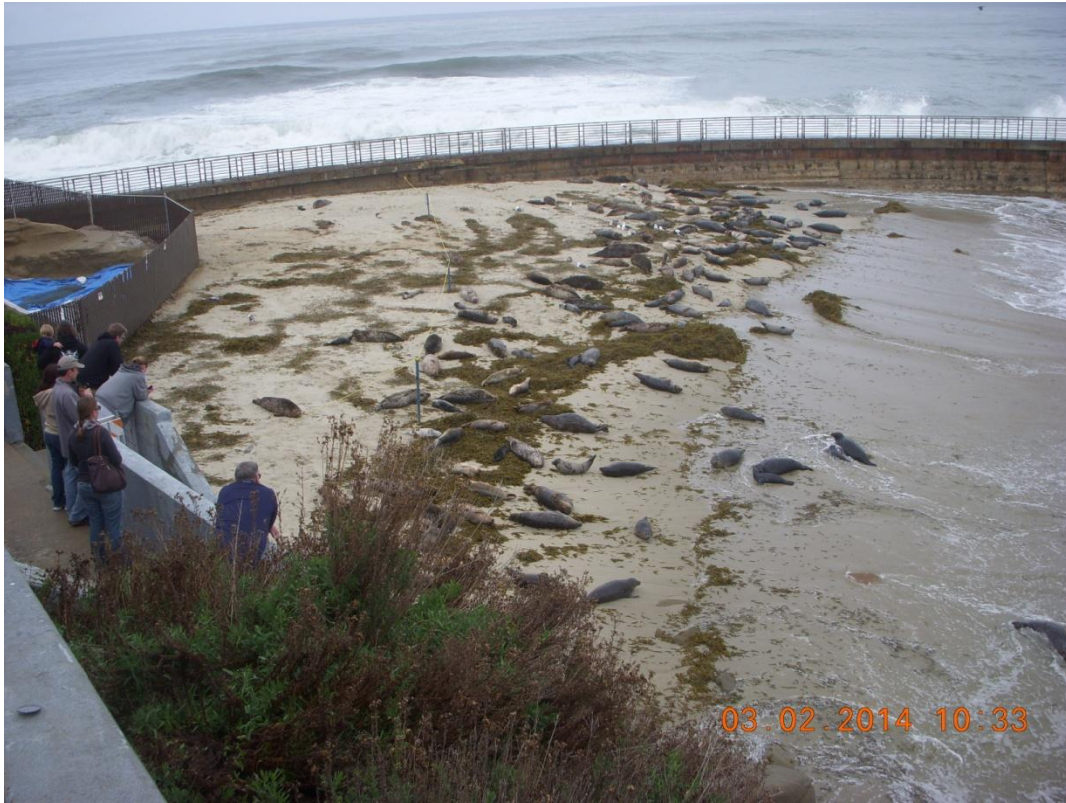
Seals across rope 3/2/2014
